Service Bulletin

MANDATORY

P0928-SB-R3

All operators of rotorcraft MDHI 369 D, E, FF, HE, HS and 500N fitted with External Cargo Pod DG500 embodied by CAANZ STC 11/21E/2 in accordance with NTech MB 25.00.129 up to and including R3.

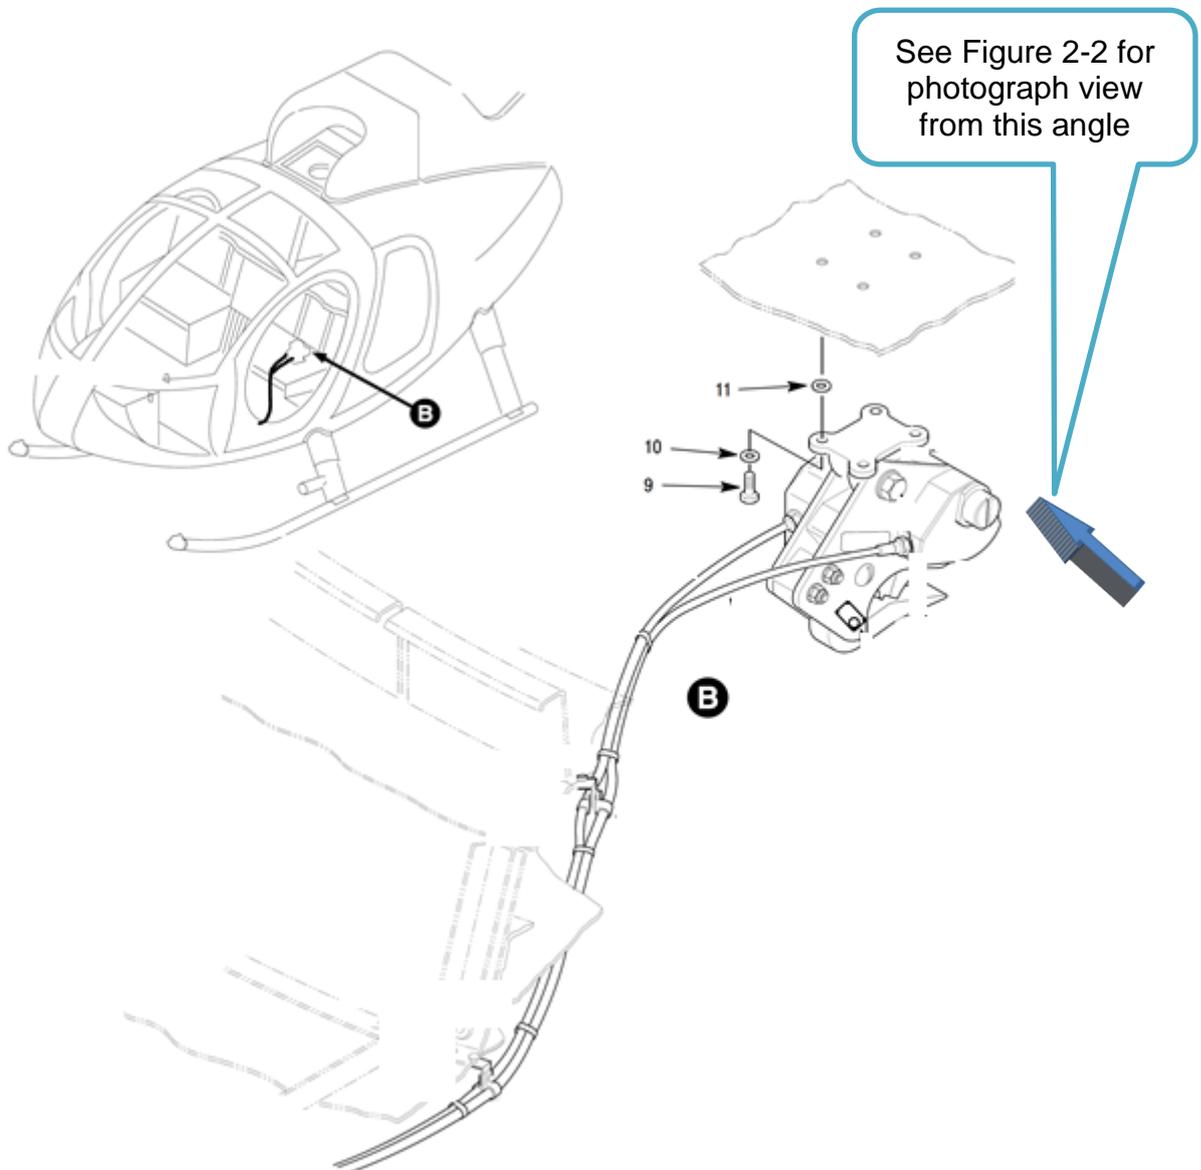
Figure 2-1: Typical Cargo Hook Installation

The cargo hook is fitted under the belly of the fuselage at FS 99.3, see Figure 2-1.

The hook provided by MDHI is attached using bolts NAS1304-6 (Qty 4, item 9 in Figure 2-1) and washer AN960-416L (Qty 4, item 10 in Figure 2-1).

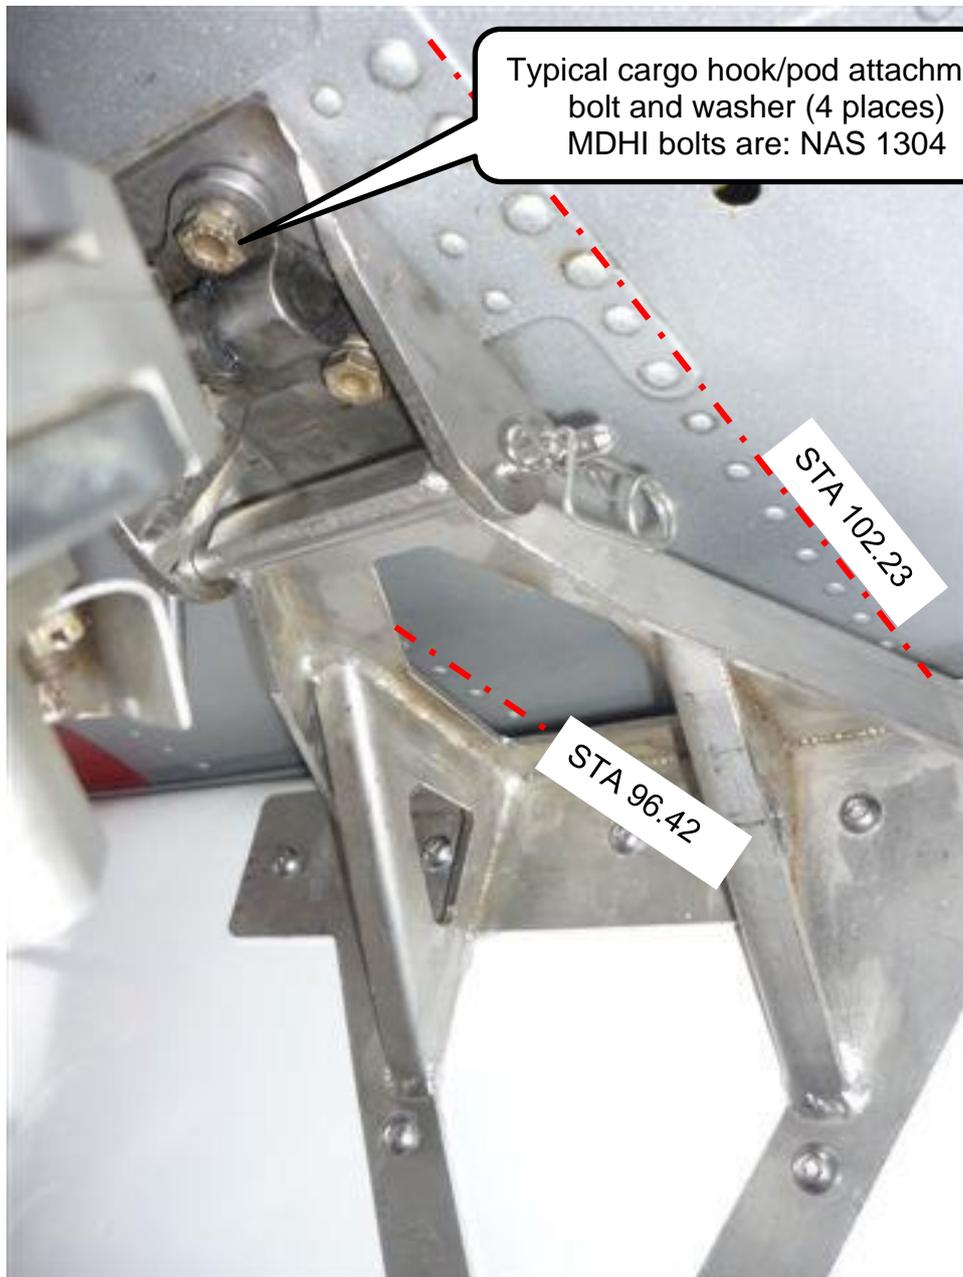
Figure 2-2: Inboard fitting of DG500 Cargo Pod

Modification Bulletin MB 25.00.129 installs the cargo pod with an inboard fitting that shares the hard point attachment with the cargo hook, see Figure 2-2. The fitting is fabricated from 5 mm thick stainless-steel sheet, which required replacement of the attaching bolts for a longer dash length.

Cargo attachment bolts (see Figure 2-2) are replaced in accordance with § 3.3 step 1 of MB 25.00.129, without explicit specification of bolts or length.

Identify the cargo hook/pod attachment bolt type (refer Figure 2-2). This should be clearly visible on the bolt head.

- 1) Inspect cargo hook/pod bolts.
- 2) If NAS 1304 bolts are installed with correct length (refer note 1 below), continue to § 3.2.
- 3) If alternative fasteners used, replace immediately with NAS1304 or NAS6604 with correct length (refer notes 1 and 2 below) and report the fasteners being replaced using Form NT10 attached.

- 1) Ensure the bolts are the correct type as per the approved STC of the hook and length is suitable (refer note 1 below).
- 2) If the bolts are too short, replace the bolts immediately with the correct length (refer note 2 below). Lockwire the bolts if required as per the approved cargo hook STC and report to NTech on the bolts removed and installed using form NT10 attached.

- 1) Inspect cargo pod bolts.
- 2) If NAS 1304 bolts are installed with correct length (refer notes 1 and 2 below), continue to § 3.2.
- 3) If alternative fasteners used, replace immediately with NAS1304 or NAS6604 with correct length (refer notes 1 and 2 below) and report the fasteners being replaced using Form NT10 attached.

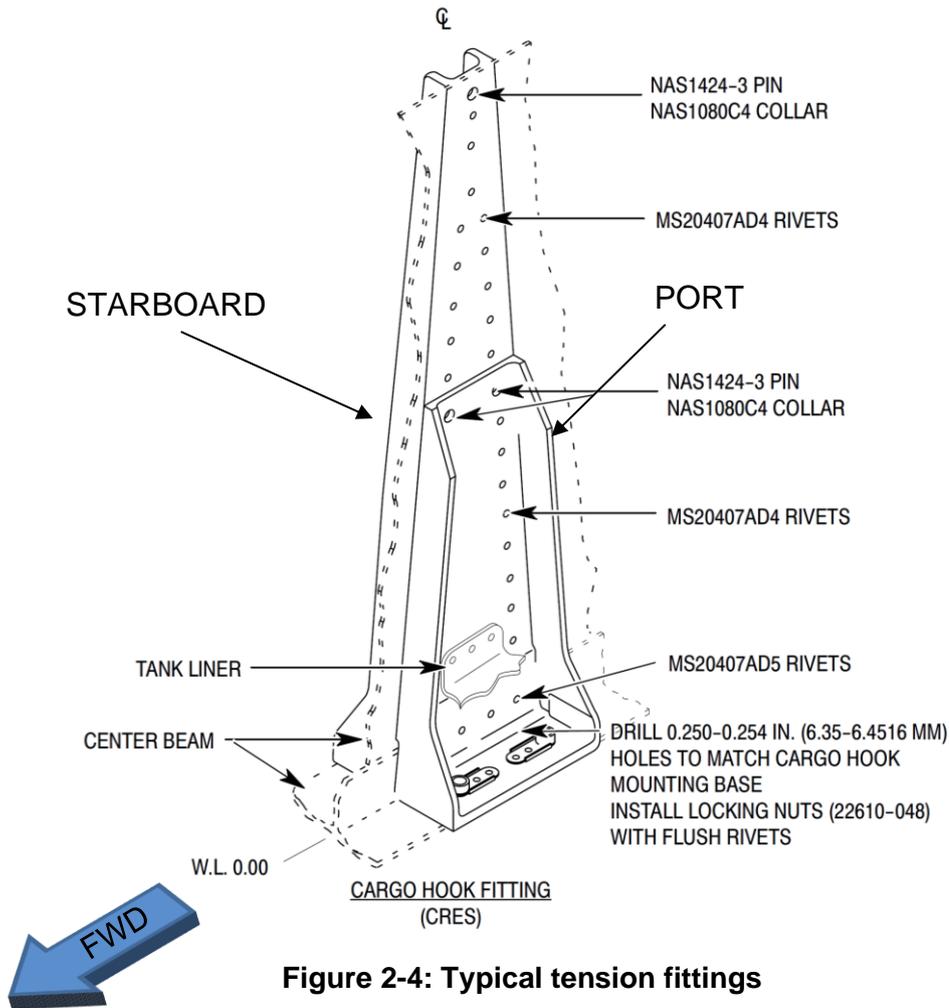
Gain access to the Cargo Compartment Centre Beam in accordance with reference 2 (HE/HS variant) or reference 4 (D, E, FF or 500N versions). Inspect for any signs of buckling of the beam and/or reinforcing stiffeners at, or in between, the stiffeners at STA 96.42 and STA 102.23 (shown in Figure 2-3).

- If signs of buckling are observed: proceed as per the Structural Repair Manual referenced, which may require a temporary restriction of floor loading limited to 400 lb maximum, in which case discontinue conducting cargo hook operations until permanent repairs are performed.
- If no buckling is observed, inspect for any other signs of (suspected) damage caused by overloading from combined hook operations and cargo carried in the pod and report to NTech using NT10 attached.
- If no other damage is observed, no further action is required.
